## Working to Protect Your Community and Environment

### FLYROCK BACKGROUNDER

February 2019

Doug Tripp, MASC, MEd

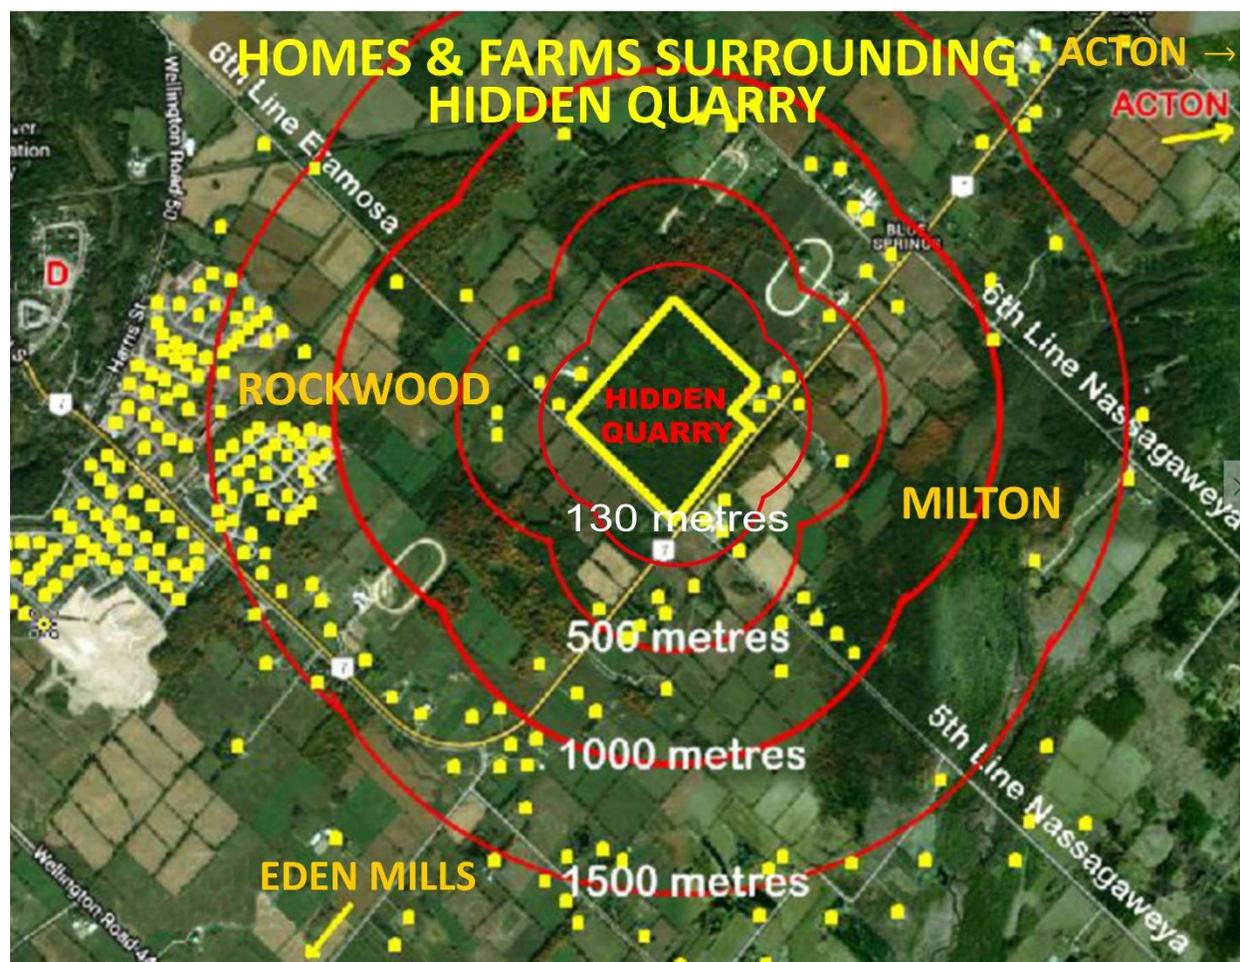
JDCL’s blasting consultant, Explotech, used the Terrock model to calculate a range of 129 metres. However, because of the considerable uncertainties in bedrock blasting, especially in the porous, fissured limestone rock known as Karst, the Terrock model applies a safety factor of two times to protect buildings and equipment, and a further two times to protect personnel. That is, a safety factor of four times should reasonably be applied in the HQ case bringing the safe setback to 526 metres. The USBOM calculation gives approximately the same result by a different method.

If setbacks of 500 metres or more were used, it would be virtually impossible to work the HQ site—it is too close to some residences and the heavily travelled Highway 7, and it is too small for a 500 metre radius exclusion zone to fit on the site itself.

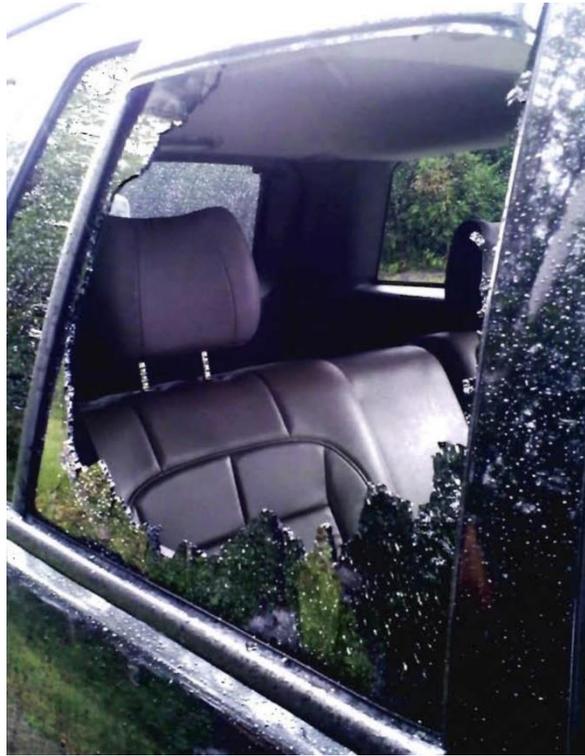
*Flyrock damage 2009 Pakenham Ontario*
